EVALUATION OF A PRE-ACTIVATED SEALAND SELF-SEALING CONCEPT FOR PROTECTION AIRCRAFT FUEL TANKS AGAINST SMALL ARMS PROJECTILES **EVALUATION OF A PRE-ACTIVATED SEALANT** SELF-SEALING CONCEPT FOR PROTECTING

SEPTEMBER 1975

TECHNICAL REPORT AFML-TR-75-22 FINAL REPORT FOR PERIOD DECEMBER 1972 - JUNE 1973

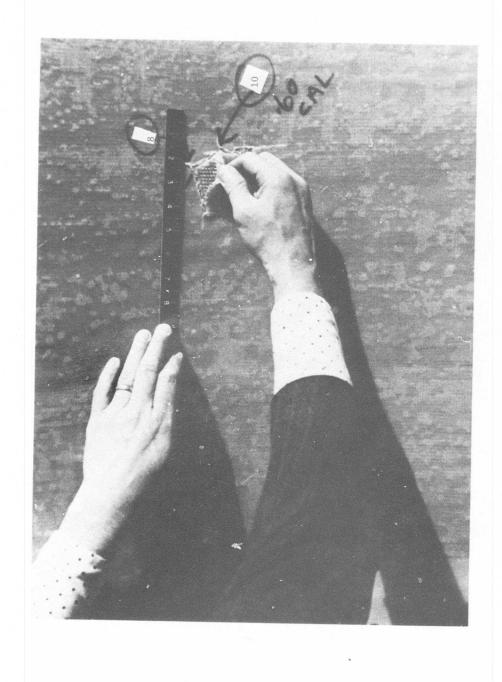
Figure 16. Exit Test Panel, .60 Cal. Shot
